# Uyemura Immersion Tin Process Presa<sup>®</sup> RMK-30 Evaluation Report

- Surface Structure
- Purity
- Wetting Balance
- Surface Insulating Resistance
- Electrochemical Migration

*C. Uyemura & Co., Ltd.*

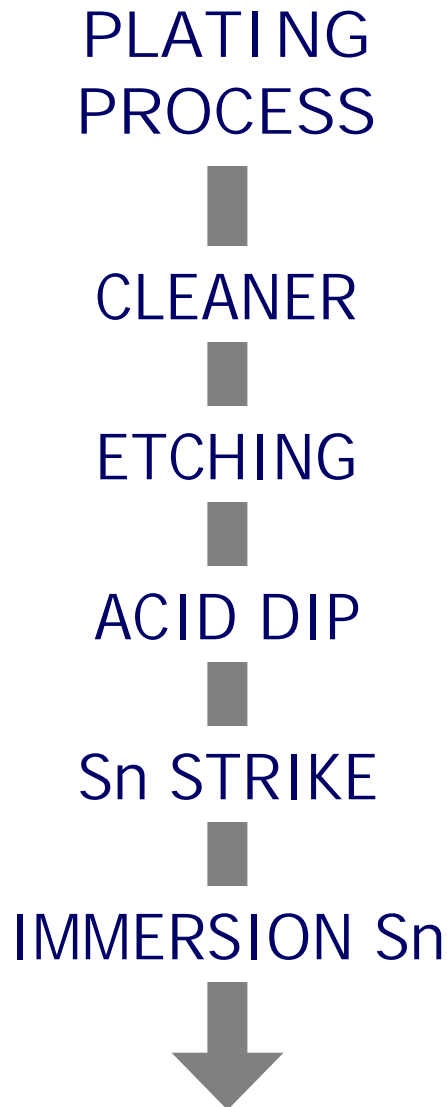
# Sample preparation

## CONDITIONS:

- Sn STRIKE  
RMK-30, 30C, 30sec.
- IMMERSION Sn  
RMK-30, 70C, 12min.

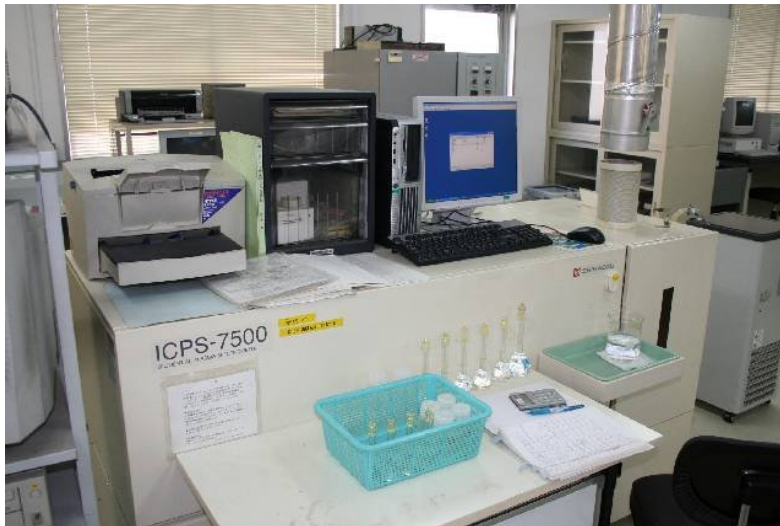
## Result

Tin	Approx. 99%
Additive	1.03%
alkaline and alkaline-earth metal (Na, K, Mg, Ca)	Slightly detected
Other metals (without copper)	Not detected

Approximately 1% additive was included in RMK-30 tin coating. The other metals were not detected by ICP measurement.

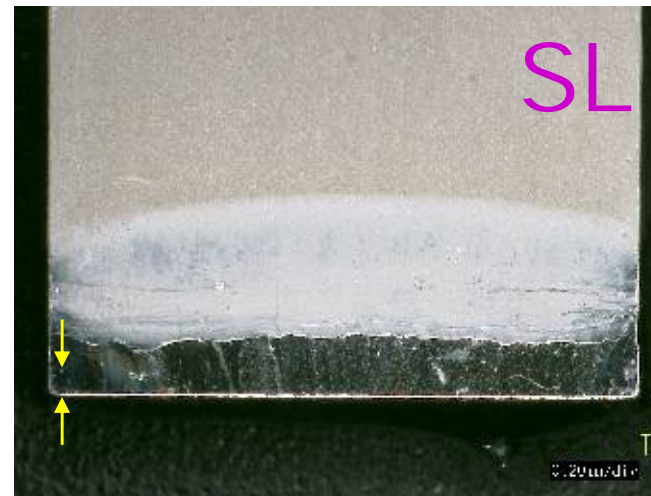
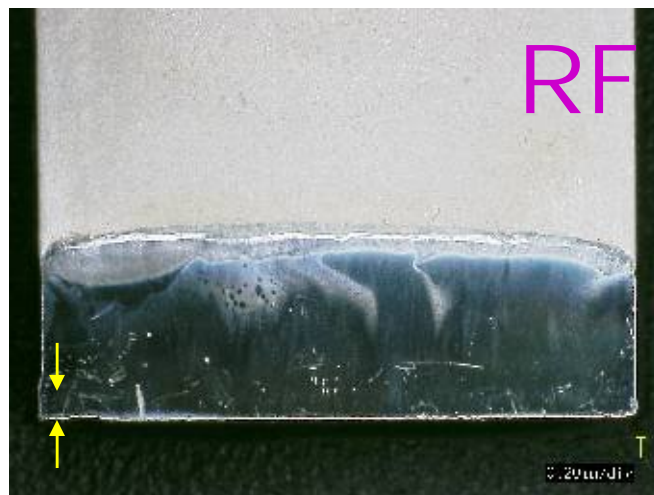
# Wetting balance #3

Appearance after wetting balance test

Immersion  
Depth  
0.2mm

Except for 'Steam Aging', RMK-30 showed good performance (ZCT, Fmax, appearance).

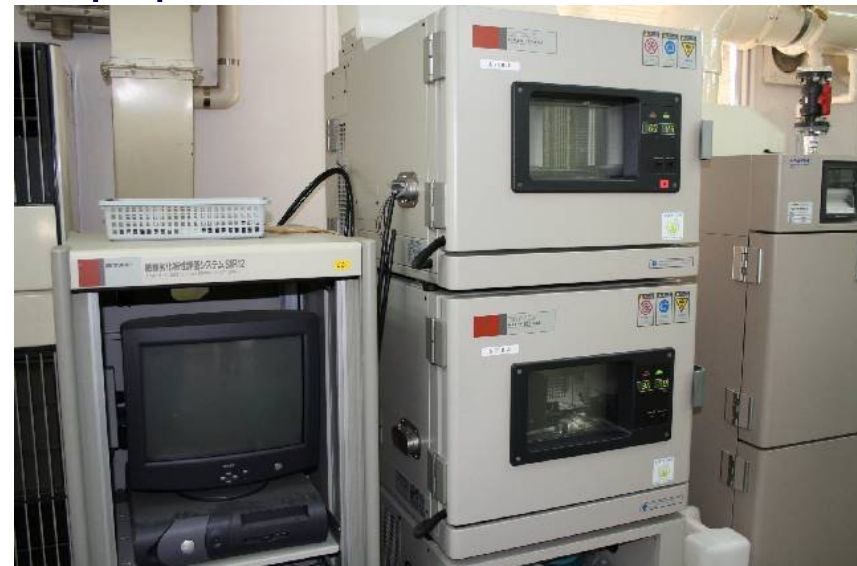
Equipment: ETAC SIR12

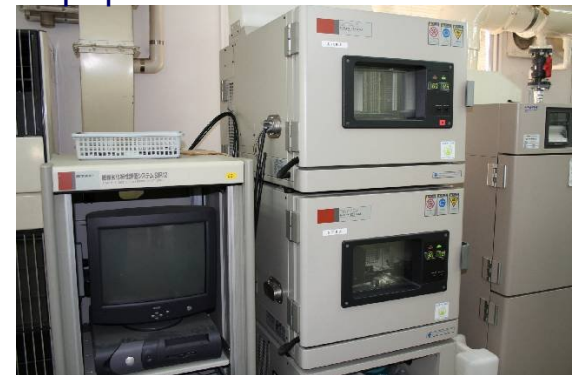
Equipment: ETAC SIR12

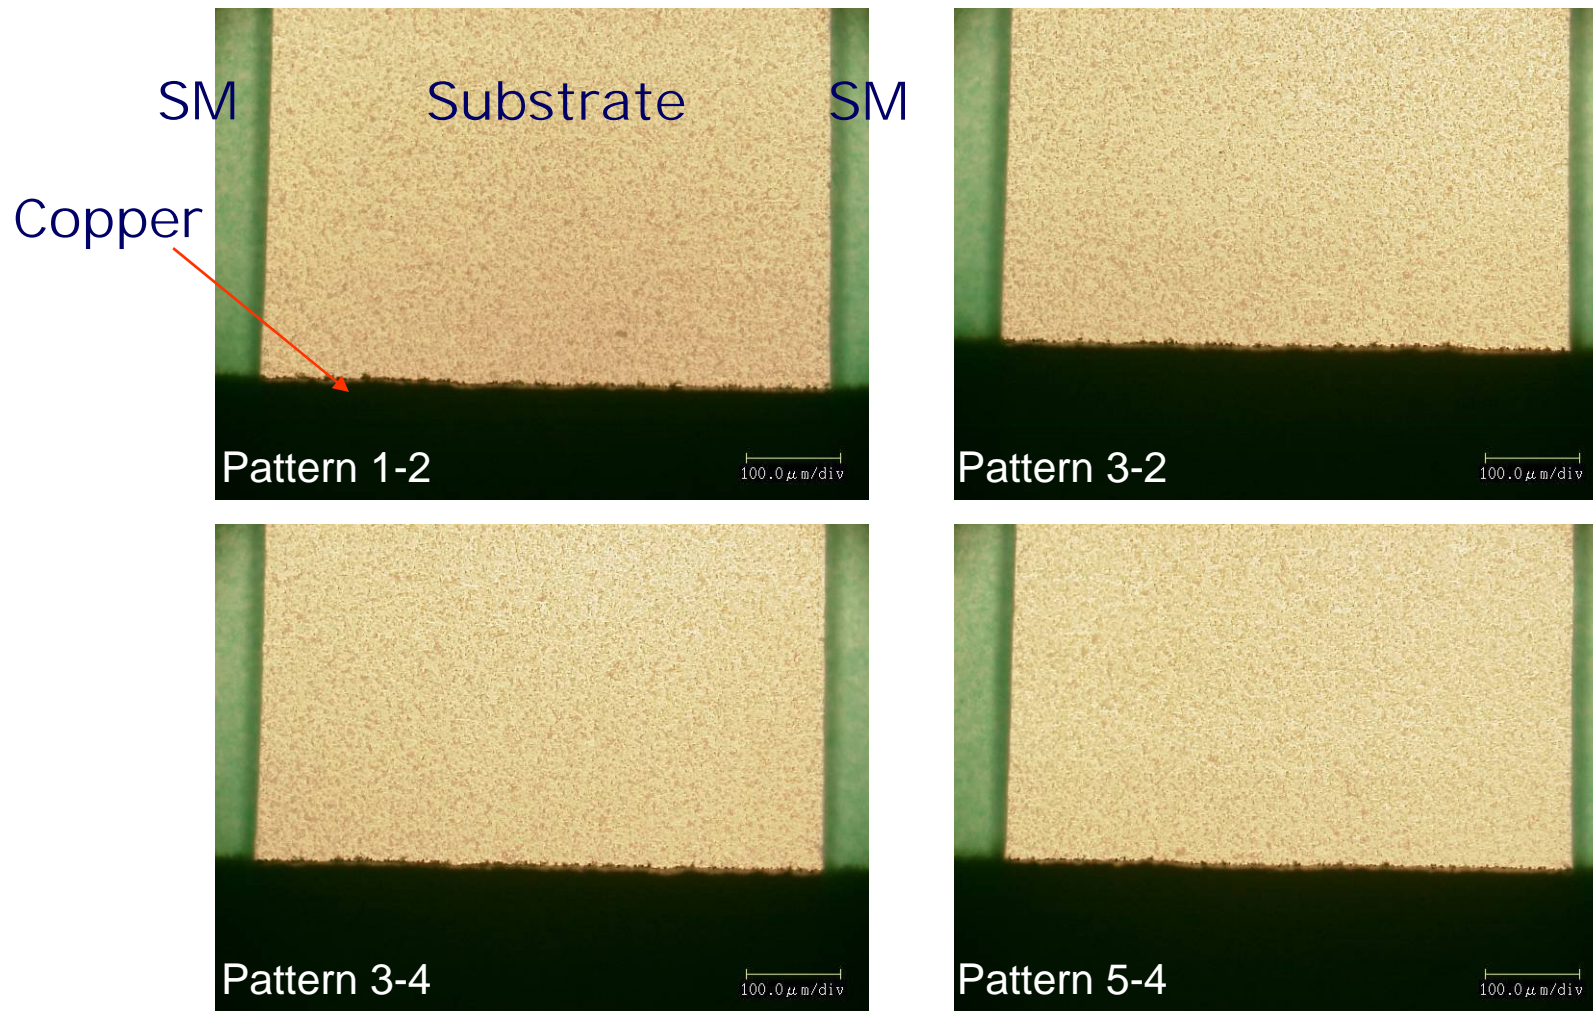
# Electrochemical migration #3

Visual inspection with backlighting / No filament growth

No migration was detected by the real time monitoring (40msec switching). And it was also confirmed by visual inspection with backlighting.
