# Study of Suitable Palladium and Gold Thickness in ENEPIG Deposits for Lead Free Soldering and Gold Wire Bonding

Yukinori Oda, Masayuki Kiso, Seigo Kurosaka, Akira Okada, Kota Kitajima, Shigeo Hashimoto\*

## Abstract

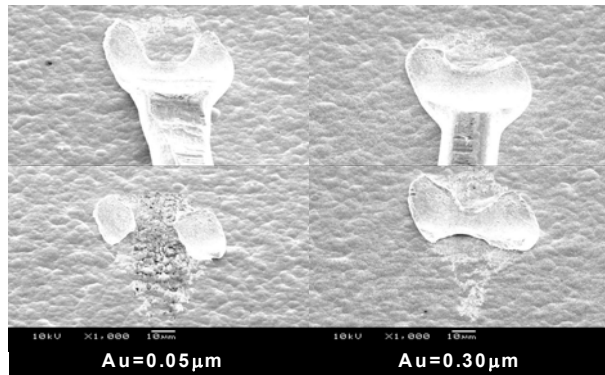
Points with 6.5g wire pull strength in the gold deposit thickness of 0.05 $\mu$ m and those with 11.5g strength in the gold deposit thickness of 0.3 $\mu$ m were chosen, to conduct SEM observations on the secondary bond surface after the wire was pulled. Fig.-3 shows the results of these observations. Observation on the fracture surface indicated a wide difference

**Fig.-3 Difference in shape between secondary wire bond when making change to gold deposit thickness**

between the 2 gold thicknesses tested. Exposed underlying metal was evident in the case of the 0.05 $\mu$ m gold thickness. In contrast with the 0.3 $\mu$ m gold thickness no exposed underlying metal was evident.

Since gold is a soft metal, it can be theorized that unless the gold deposit has a certain level of thickness for wire bonding, the underlying metal is scraped off to degrade the pull strength. The thicker gold deposit has a cushioning effect on the bond and produces a bond of superior strength. Insufficient gold and the possibility of nickel diffusion are the main contributors to the loss of wire bond strength.

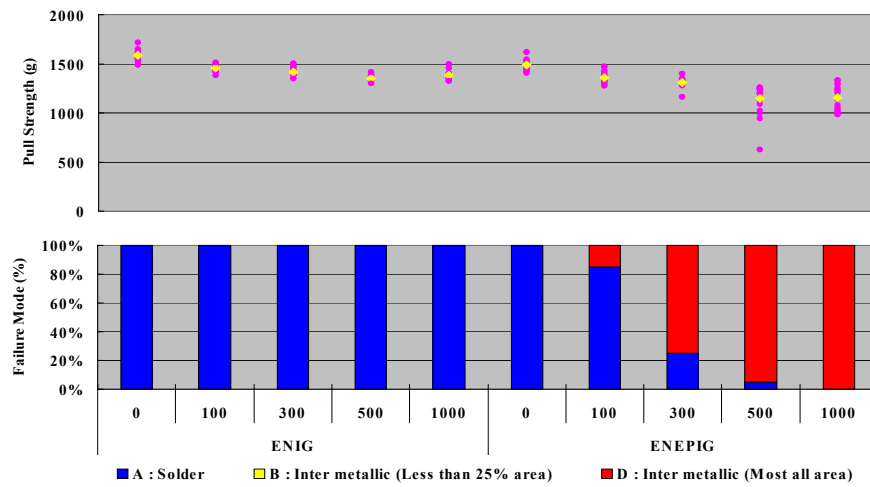
**Fig.-4 Results of Sn-3.5Ag Solderability Testing (Long-term heat treatment testing at a temperature of 150°C)**

As can be judged even from Fig.-1, the solder joint formed with ENEPIG maintains a high degree of reliability under strict reflow conditions compared to that of ENIG. Consequently, reflow was conducted at a temperature of 240°C as plated, and samples were also aged at 150°C for a period of 1,000 hours to simulate long-term reliability testing. In the previous paper, reliability evaluations were made on solder joints using Sn-3.0Ag-0.5Cu and Sn-37Pb solders<sup>(2)</sup>. In this paper, however, we made evaluations on solder joint reliabilities using Sn-3.5Ag solder and showed the results in Fig- 4. ENEPIG showed degradation in strength and fracture mode as heat treatment time elapses when using Sn-3.5Ag solder, which was the same as that shown when using Sn-37Pb solder. In addition, like the previous paper, EPMA analysis was done of the

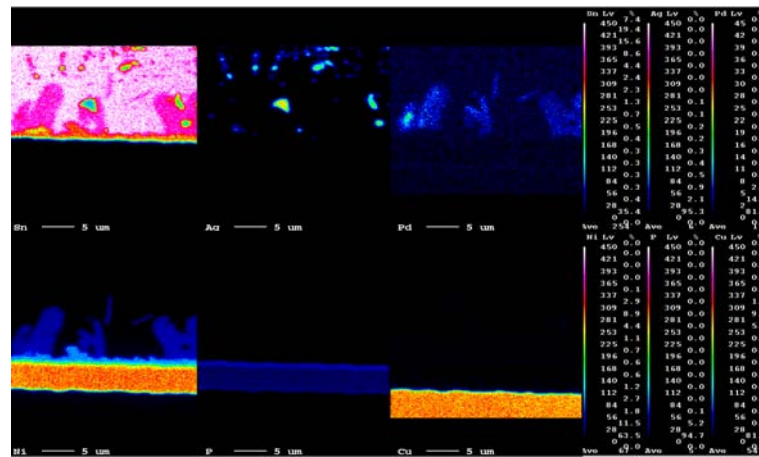
distribution of each element at bonded interfaces after 1,000 hours of heat treatment at a temperature of 150°C. It turned out as shown in Fig.-5, that Sn-3.5Ag solder showed the same palladium aggregates that were observed with Sn-37Pb solder. In contrast when Sn-3.0Ag-0.5Cu is soldered to an ENEPIG deposit, the palladium at the IMC is uniformly distributed with no signs of aggregates. This absence of palladium aggregates with SAC solder is a possible reason why the solder joint reliability is higher than either Sn-37Pb or Sn-3.5Ag, under the conditions of testing.

**Fig.-5 Distribution of each element at bonded interfaces after heat treatment at a temperature of 150°C for a period of 1,000 hours, after mounting Sn-3.5Ag solder balls to ENEPIG deposit**

Applying long-term heat treatment under these conditions, two layers were found one was columnar and the other was of uniform crystal structure. The results of EPMA mapping (Fig. 5) show that the palladium aggregates were found only in the columnar alloy layer.

The EPMA measurement in Fig. 5 showed the distribution of the palladium deposit thickness in alloy layers.

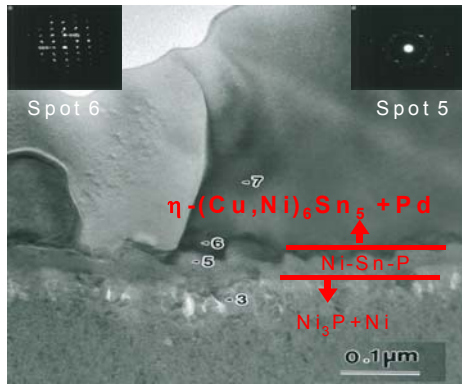
The details of the IMC layers for Sn-3.0Ag-0.5Cu and Sn-3.5Ag were analyzed by TEM. Fig.-6 shows TEM image in the vicinity of IMC layers with Sn-3.0Ag-0.5Cu soldered to the ENEPIG deposit after applying heat treatment at a temperature of 150°C for a period of 1,000 hours, and Fig. 7 shows the result of EDS analysis of the spots shown in the micrograph. According to the results of EDS measurement and diffraction measurement, Spot 3 is a layer referred to as the “phosphorous-rich layer” and assigned Ni<sub>3</sub>P+Ni. Spot 5 was assigned Ni-Sn-P since Ni, Sn and P were detected and no crystals were defined by diffraction<sup>(3)</sup>. The Spots 6 and 7 had the same hexagonal crystal as that of Cu<sub>6</sub>Sn<sub>5</sub> from the results of TEM diffraction measurement. In addition, since the EDS measurement result showed the detection of Ni, these spots were identified as (Cu, Ni)<sub>6</sub>Sn<sub>5</sub>. Furthermore, since this layer had uniform palladium distribution, the Spots were assigned as (Cu, Ni)<sub>6</sub>Sn<sub>5</sub>+Pd. Subsequently, Sn-3.5Ag was soldered to the ENEPIG deposit, and we then conducted TEM and FE-SEM measurement of the IMC layers formed after aging at a temperature of 150°C for a period of 1000 hours. The results are shown in Fig.-8.

**Fig.-6 TEM observation on IMC with Sn-3.0Ag-0.5Cu soldered to ENEPIG deposit after heat treatment applied at a temperature of 150 degree C for a period of 1,000 hours**

**Fig.-7 Results of EDS of TEM Image in Fig.-6**

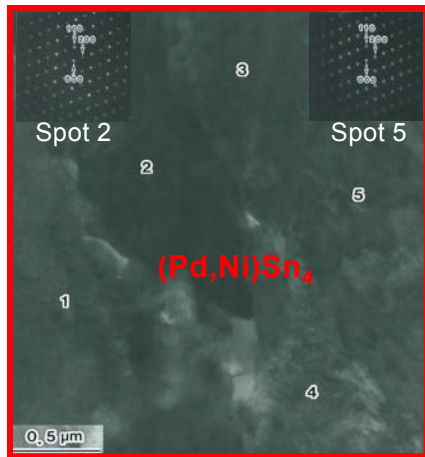
Spot	P	Ni	Pd	Sn
2	0.0	17.9	3.7	78.4
5	0.2	19.1	0.7	79.9
7	10.8	66.0	0.0	23.2
8	0.2	44.7	0.0	55.1
9	0.3	43.4	0.0	56.2

Fig.-9 Results of EDS of TEM Image in Fig.-8

Further analyses were conducted on IMC Layer Spots 7 to 9 in the lower main part, the results of the EDS analysis shown in Fig. 9. Furthermore, from the diffraction results, we determined that the Spot 7 was Ni-Sn-P layer, and the Spots 8 and 9 were Ni<sub>3</sub>Sn<sub>4</sub> layers.

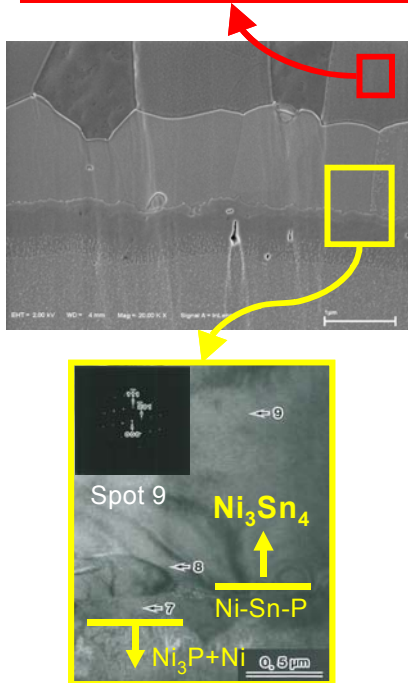
Fig.-8 TEM and FE-SEM observations on IMC with Sn-3.5Ag soldered to ENEPIG deposit after heat treatment applied at a temperature of 150°C for a period of 1,000 hours

Subsequently, the diffraction result indicates that columnar parts (Spots 1 to 5) of the upper layer are of structure close to Ni<sub>3</sub>Sn<sub>4</sub>, while the EDS result indicates a ratio obviously different from that of Ni<sub>3</sub>Sn<sub>4</sub>. These ratio differences were observed with thick<sup>(3)</sup> gold deposits where an alloy (Au, Ni)Sn<sub>4</sub> was identified. Since AuSn<sub>4</sub> and PdSn<sub>4</sub> produce the same orthorhombic crystal and due to the element ratio of EDS, we determined this alloy as (Pd, Ni)Sn<sub>4</sub>. This (Pd,Ni)Sn<sub>4</sub> alloy has portions that vary in palladium content.

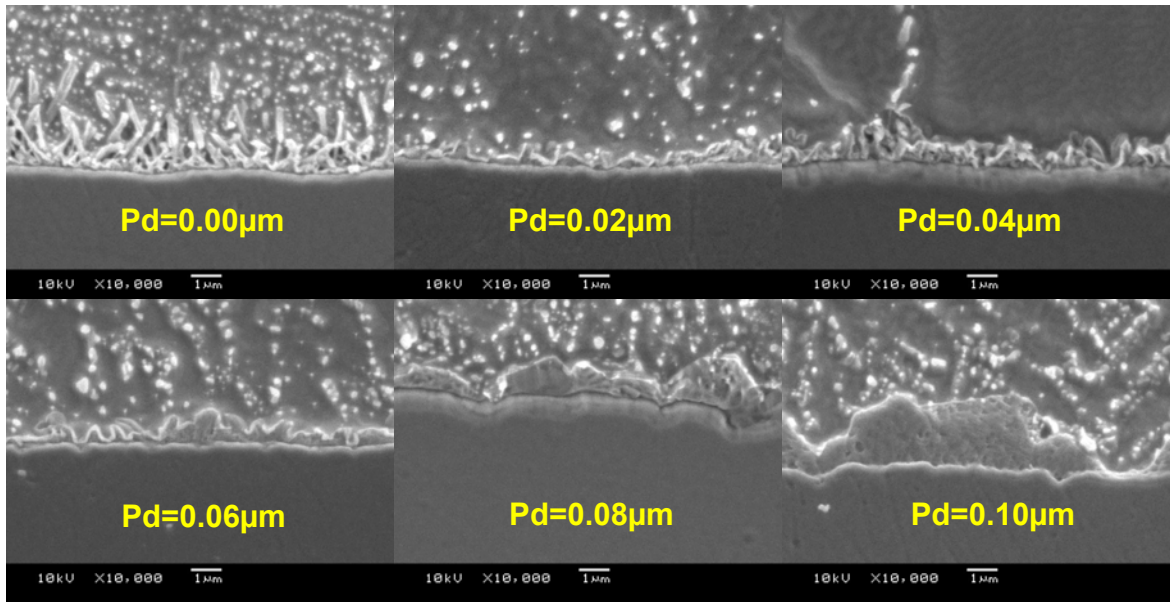
Additional observations on the cross section of alloy layers with varying palladium thicknesses were conducted. The reflow process was conducted once at a temperature of 240°C and gave the results showed in Fig. 10. The results indicate that ENIG (Pd=0.00um) has formed needle-like alloy layers and ENEPIG has formed uniform alloy layers. However, if the palladium deposit thickness is increased to 0.08um or higher, the alloy layers become markedly thicker. The increased thickness has an adverse effect on the reliability of the solder joint.

**Fig.-10 Photograph of alloy layer after conducted the reflow process once at a temperature of 240°C on Ni-P/Pd/Au deposit with changed palladium deposit thickness**
